PIPELINES

Case study: System cuts corrosion risk and noise on a Gulf of Mexico offshore platform

By Hani Almufti, Cogbill Construction (RedLineIPS)

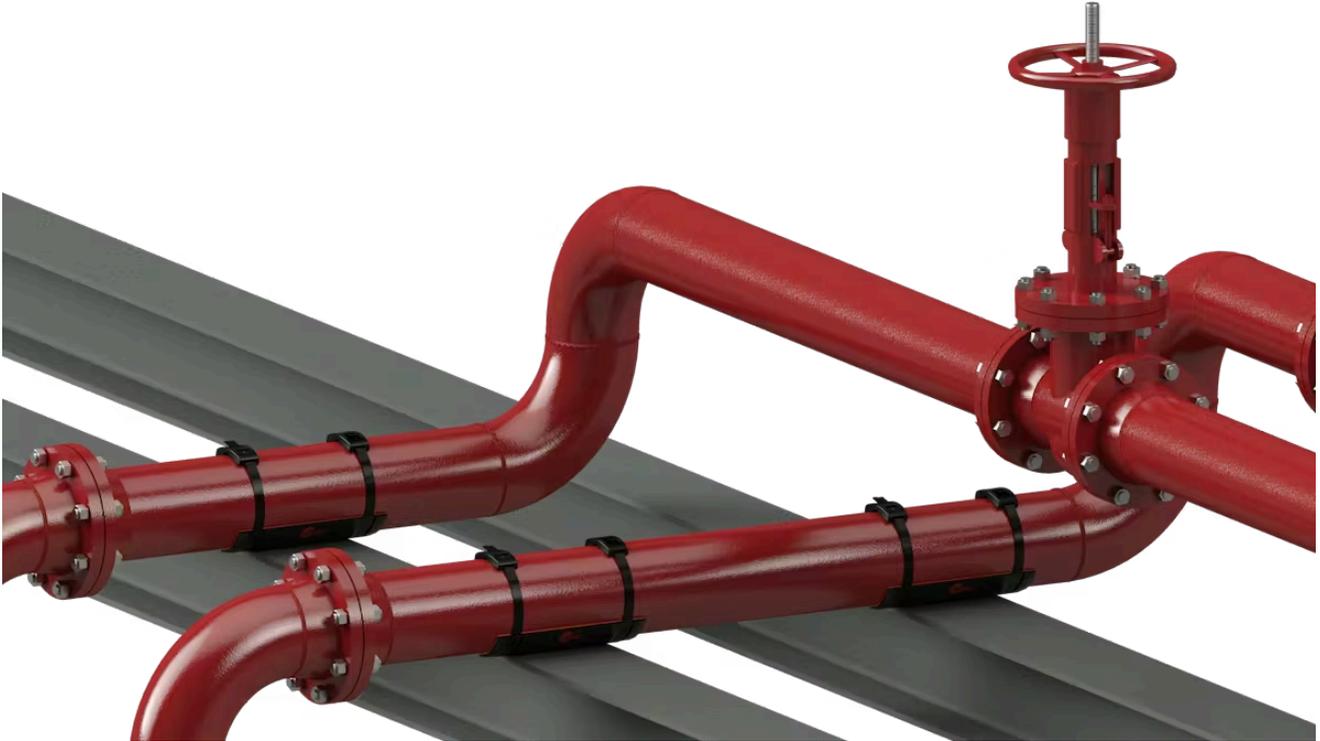
The illustration highlights the red firewater lines mounted on FRP SmartPads with bonded Hydroseal gaskets, secured by non-metallic SmartBands on steel beams, which isolates metal-to-metal contact and helps curb CUPS.

The system pairs a contoured FRP (fiber-reinforced polymer) saddle with a bonded, closed-cell Hydroseal gasket, secured by non-metallic SmartBands and polymer buckles. The sealed, non-metallic interface keeps moisture and salt off the pipe and breaks the metal-to-metal path, and the gasket cushions micro-movement to reduce vibration and local sound.

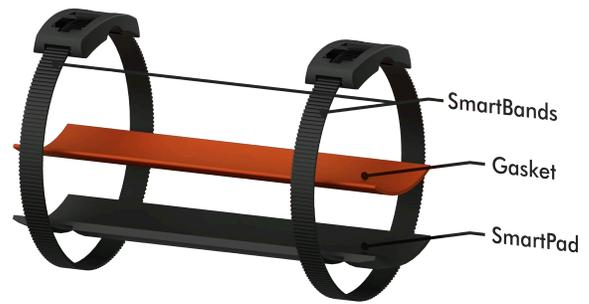
The SmartPad system (enlarged view) features non-metallic SmartBands, buckles clamp, a contoured FRP SmartPad saddle and a bonded Hydroseal gasket.

All work was cold on live lines. Crews set the saddle, tensioned bands with a preset tool, and trimmed the tails. For inspection, they cut the bands, lifted the saddle, wiped the surface, inspected and re-banded. In typical access, the open-inspect-reseal cycle took minutes per support, enabling supervisors to fold visual checks into routine rounds.
